The Oscillator

The Official newsletter of the DVHRC

SPRING 2016

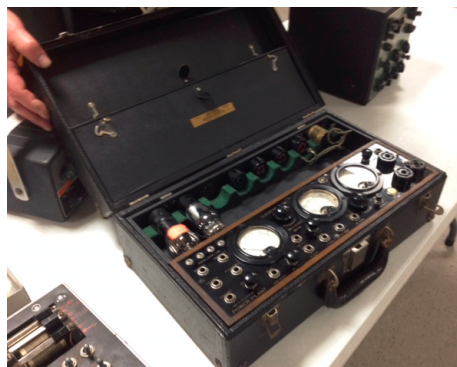
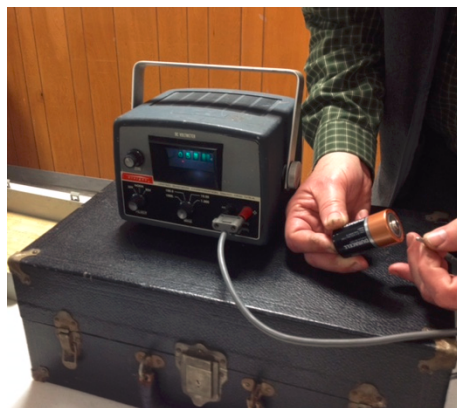
Above: Chuck Azzalina, a self-admitted test equipment enthusiast, showed off several items including early tube testing equipment and a more "modern" digital voltmeter.

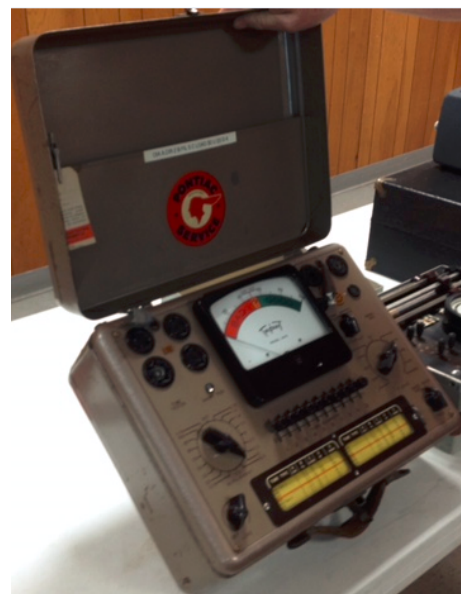
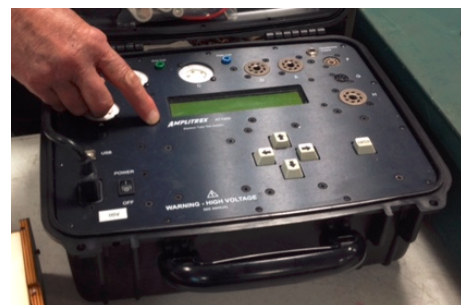
Above: Pete Grave shows a "Pontiac" tube tester for testing of only Pontiac automobile radios, of course. Seen second is a Russian tube tester and below that, a more modern tube tester.

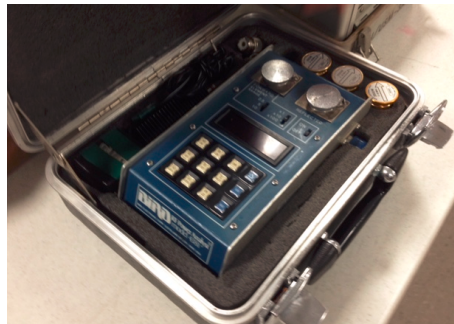
Above: Dave Dean brought a Bird RF Power Analyzer in nice case including frequency/power range elements and the "Righteous Reformer"

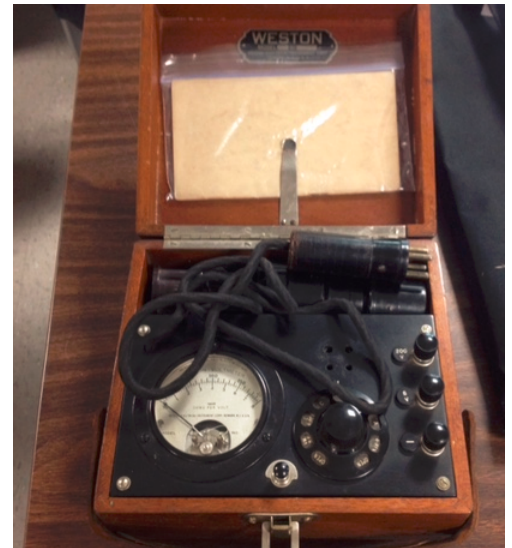
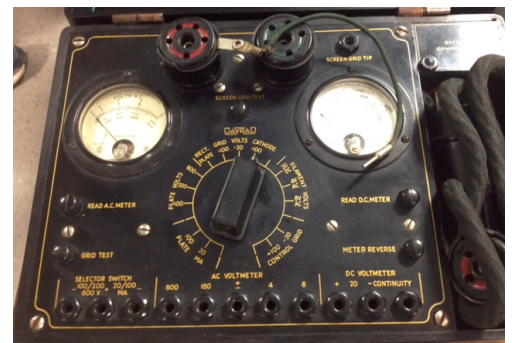
Above: Jiri Placek shows off some vintage tube testers made by Weston and Dayrad.

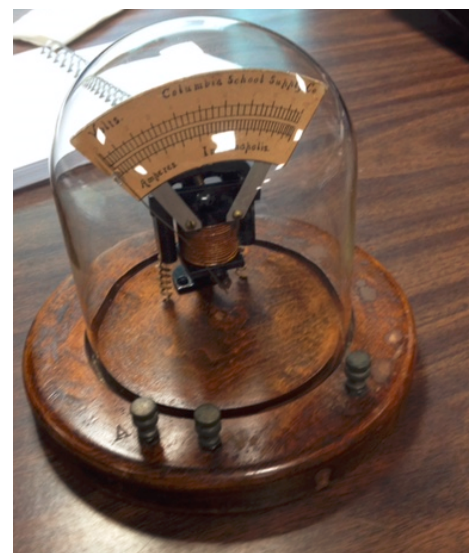
Above: Dave Snellman brought an old Volt/Amp meter circa 1910 used in education.

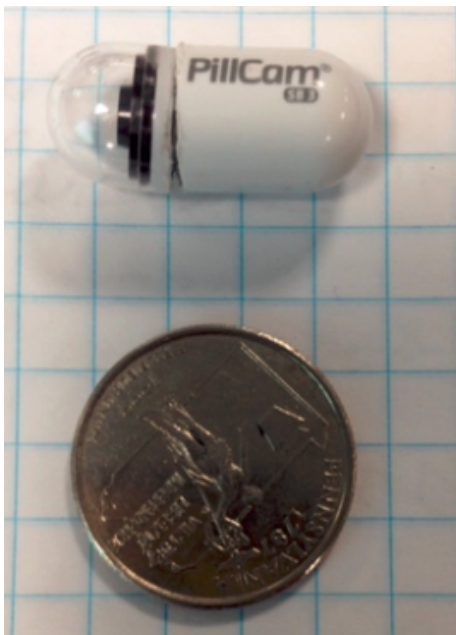
Above: Our smallest instrument was a more modern "pill-cam" used in certain medical procedures as displayed by Jack Meyer.

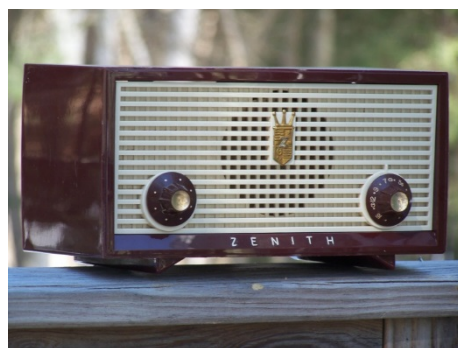
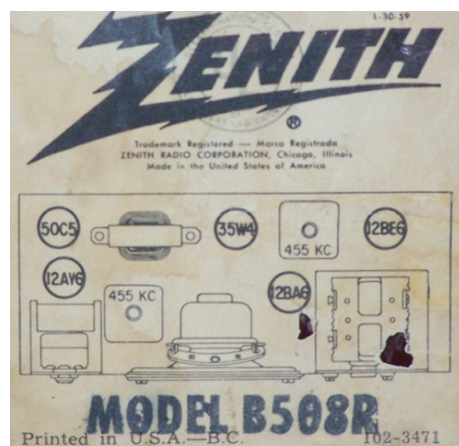
I thought to myself..., 2 electrolytics, 3 paper caps and no selenium rectifier, what could be easier? The schematic and Sams sheet (with thanks from NJARC's Aaron Hunter) were located and I got to work. In short order in one

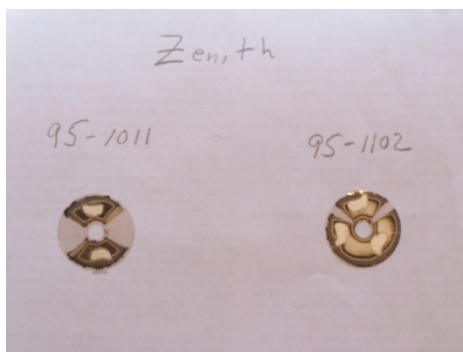
Internally, the disc is situated between two shoes. As you can see in the photo, they left their mark. Trying to take a reading when they are diseased is nearly impossible. You will need to disconnect each coil to take your readings. In the case of this radio, I should have been reading something close on the caps of the

As I'm sure most of you know, no two IF cans are alike. In my case, the capacitors for the IF were built into the IF base inside the can. They were made of a single mica disc with a coating.

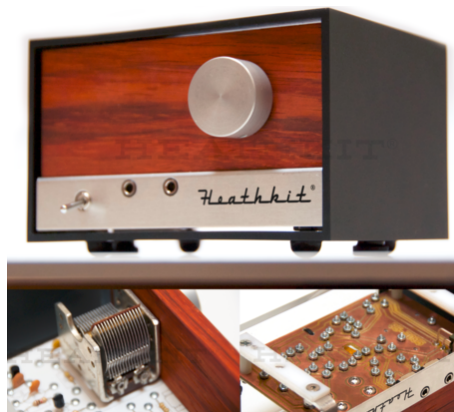
NEW HEATHKIT TRF KIT

The reviewer builds the GR-150 1-stage TRF receiver but reserves his excitement. See the link below or search for associated articles. <http://swling.com/blog/2016/01/james-reviews-the-heathkit-explorer-jr-gr-150-trf-am-radio-receiver-kit/>
